STUDY OF RESISTANT EARTH QUAKE BUILDING OF TIMBER ROOFS STRUCTURE AND ITS RETROFIT AND REDESIGN AFTER THE SEPTEMBER 28 2018 EARTHQUAKE

K. Sulendra^{1*}, G. Turu'allo², and APN Siregar³

Abstract

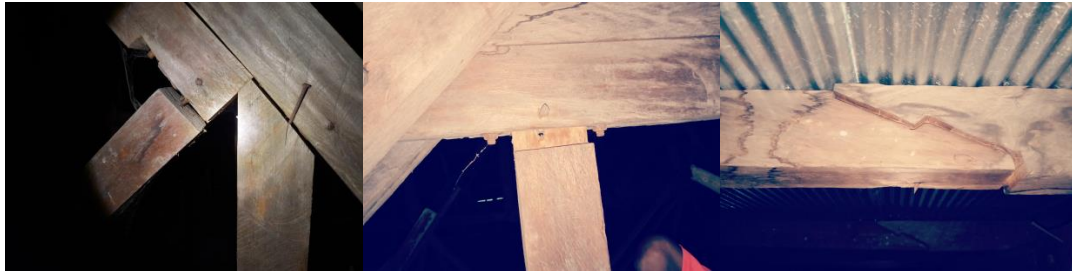
Fig. 1. Damages of Timber Joints of Timber Truss of Sigi Regency

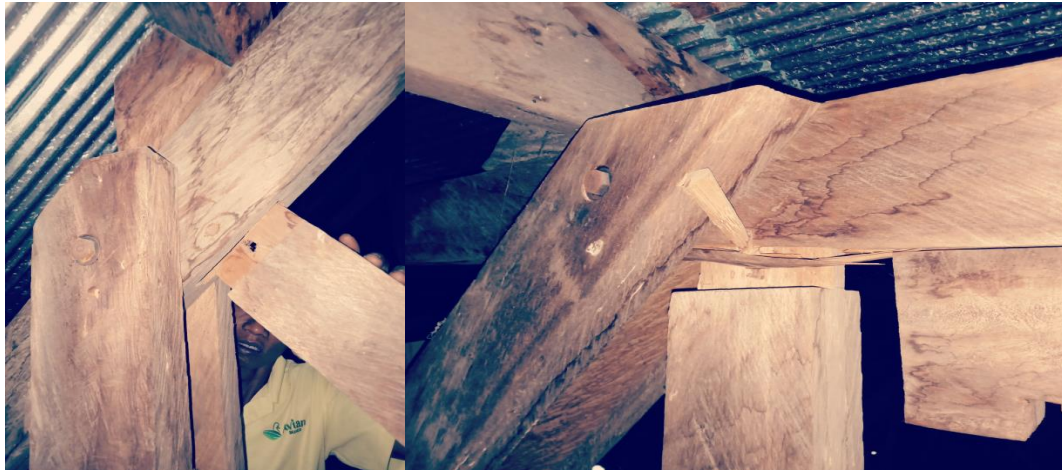
Fig. 2. Damages of Timber Joints of Timber Truss of Sigi Regency

vertical earthquake forces. In the middle and right images it is shown that there is no vertical clamp on each vertical rod module. The right picture shows only 1 (one) connection tool for each joint which should have at least 2 (two) bolts. Figure 2 above also shows the inadequacy of the dowels and bolts, so that in the tension element, failure occurs in the form of a broken dowels and the bolts attachment is pulled out of the joint. Several survey results in the city of Palu showed that there was a lateral shift in the entire roof truss with a distance of about 20 cm. This occurs due to the absence of anchorage from the walls and columns on the roof truss mount, given the acceleration of the ground surface and the large horizontal and vertical deflections when the earthquake occurred. In this case, anchorage is required at the top end of each column or a wooden beam is installed along the top of the wall. Anchoring can be done by mining(double and triple grip steel plates).

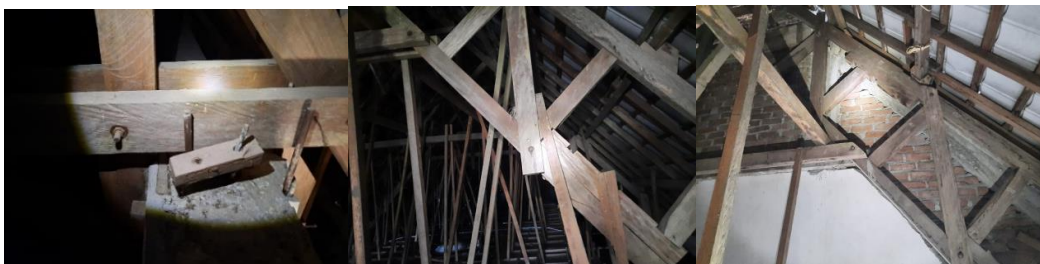
Fig. 5. Insufficient Armature In Mounts, Joining Elements and Connector.

Based on Figure 5 above, it can be shown that at the wall connection with the roof truss (Roof to Wall Connections = RWCs) there is no armature to hold the roof truss in the event of horizontal and
